# Manhole Inspection Summary

Manhole # S37CC\_029MH

Insp Date: **3/20/07 12:26 PM**

**Location** Address: **600 EAGER ST**

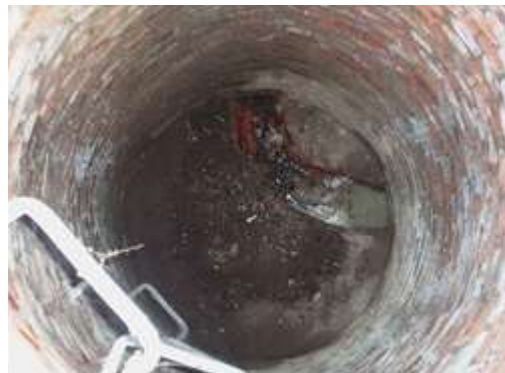
Top View

Condition: ☐ Sound ☐ Cracked ☐ Root Intrusion ☐ Deteriorated ☐ Leaks ☒ **Debris**

**Surcharge** ☒ **Evidence Of Surcharge** Depth: **2** (ft.) ☐ Active Surcharge Present

Evidence of surcharge - Bench debris.  
Channel debris.

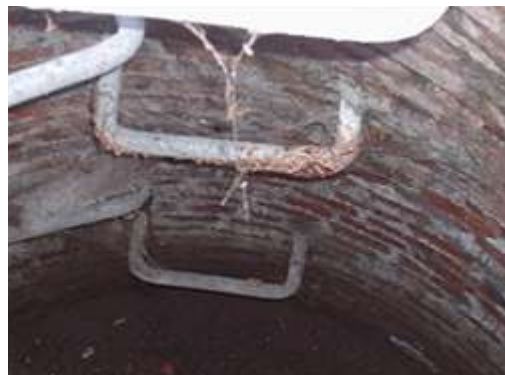
Defect

Infiltration: ☐ None ☐ Joint ☐ Cracks ☐ Mortar ☐ Roots ☒ **Wall**

**Steps** Count: **5** Missing: **0** ☒ **Corroded**

Corbel and Barrel infiltration. Corroded steps.

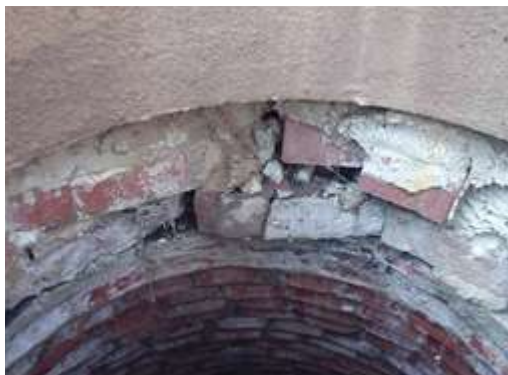
Defect

**Frame** Offset: **0** (in.) Condition: ☐ Sound ☐ Cracked ☒ **Leaks**

Condition: ☐ Sound ☐ Cracked ☐ Root Intrusion ☒ **Loose Brick** ☒ **Deteriorated**

Infiltration: ☐ None ☒ **Joint** ☐ Cracks ☒ **Mortar** ☐ Roots ☐ Wall

Frame leaks. Adjustment deterioration,  
loose brick and infiltration.

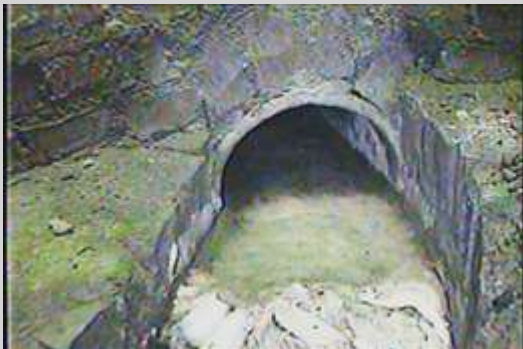
### 8 in. Circular Gravity Sewer Pipe In @ 3 O'Clock

Deposits: ☐ None ☒ **Mud** ☐ Sludge ☒ **Debris** ☐ Grease

Silt Depth: **2** (in.) Deposits Extent: **Medium**

Infiltration: **None** Pipe Seal Cond: **Cracked**
